Project Resources Inc.

## Property Access Checklist

**U.S. Environmental Protection Agency  
Vasquez Boulevard I/70 Superfund Site  
Replacement Certificate**

SITE NAME: VASQUEZ BLVD AND I-70

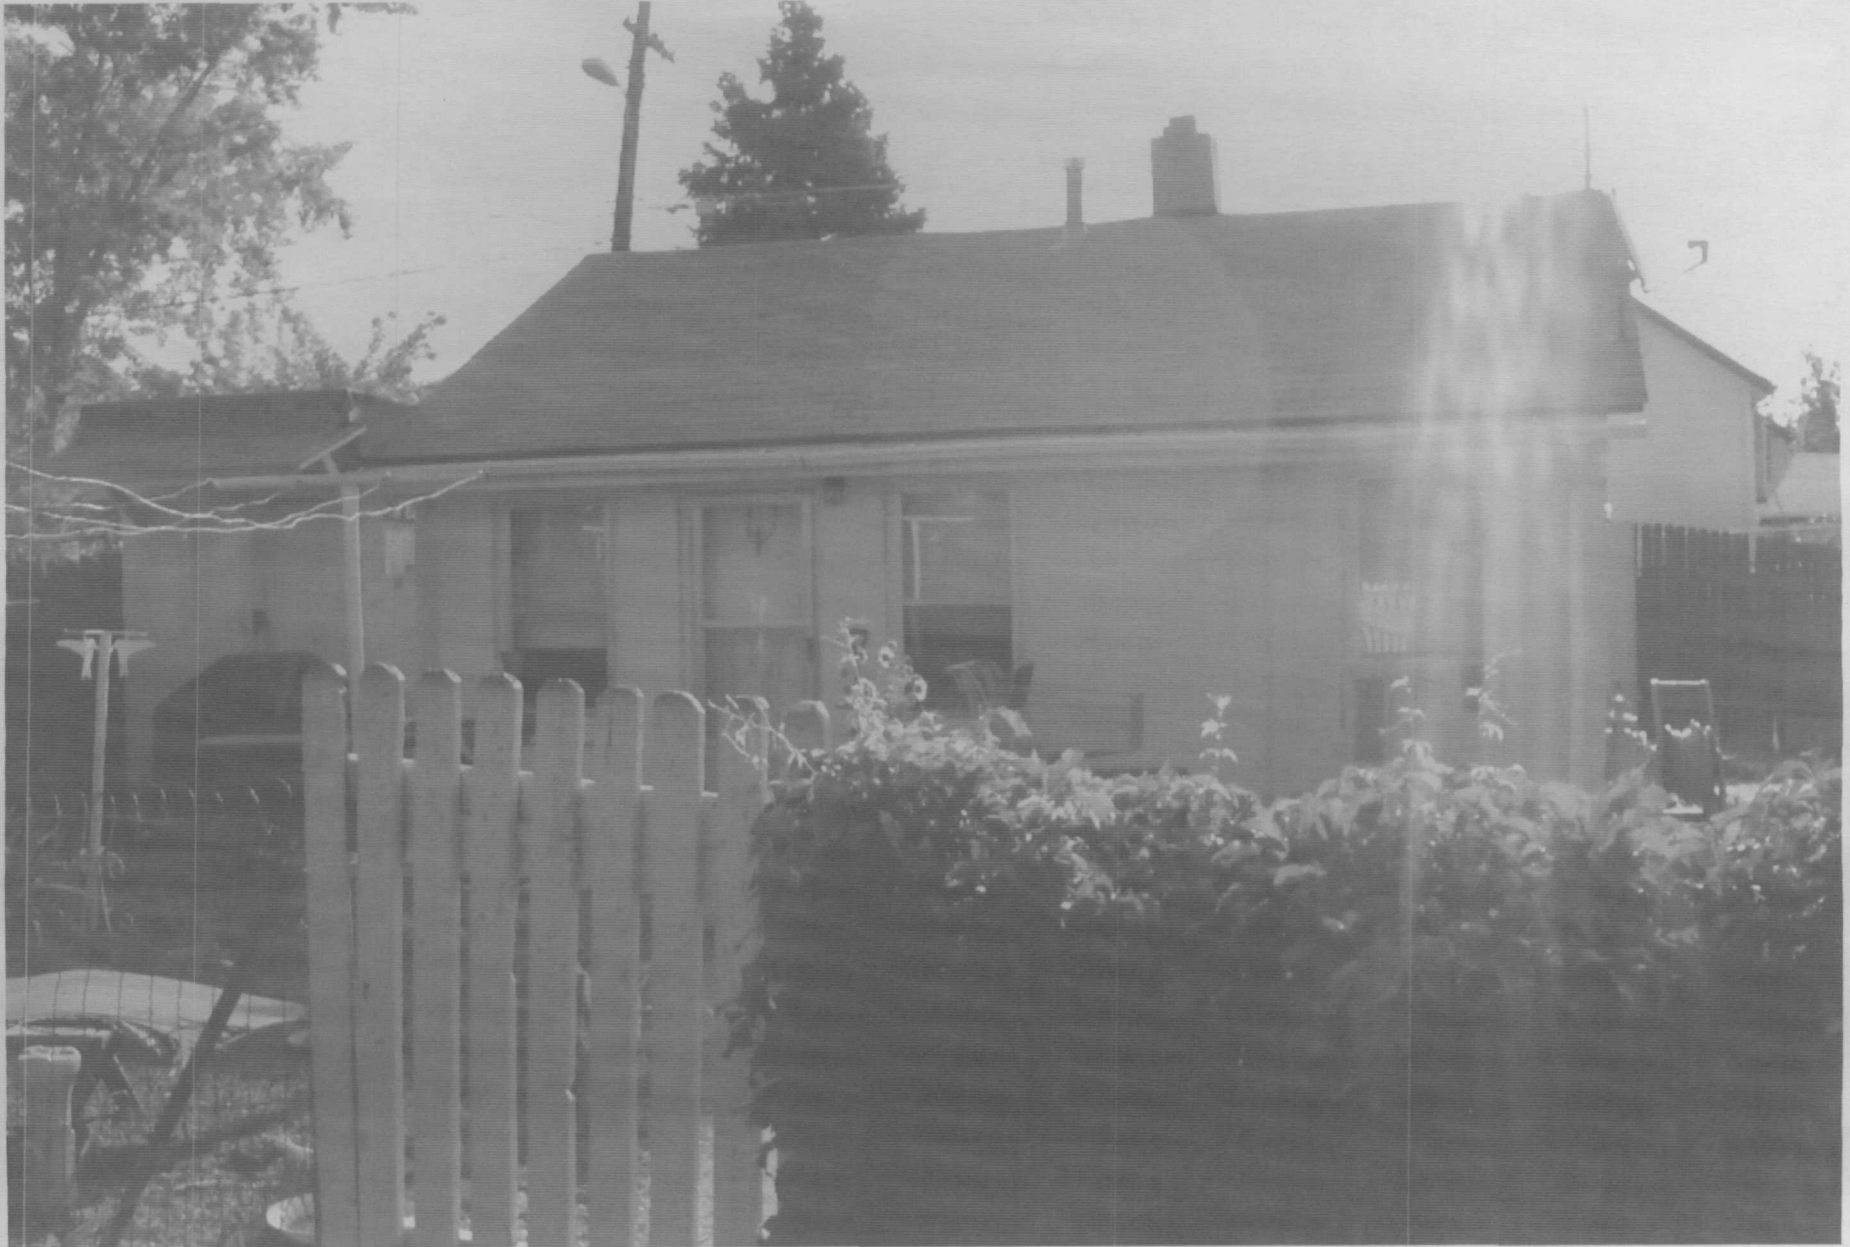
Property ID # 2391 / 4752 High Street

No lead paint was found on property

30x4 DG

4 Rose bushes  
0000 remove

DG  
100 sqft

20x15 DG

12x3 Flowerbed

Flowerbed remove

Shed  
owner will remove

24x18 sod

32x24 sod

65x26 sod

64x22 sod

do not dig 2391-001-FB (clean)  
15x30 Flowerbed remove

5294 SF to be excavated

TOTAL = 5134
